Intel[®] Pentium[®] M Processor on 90 nm Process with 2-MB L2 Cache

Specification Update

February 2005

Document Number: 302209-007

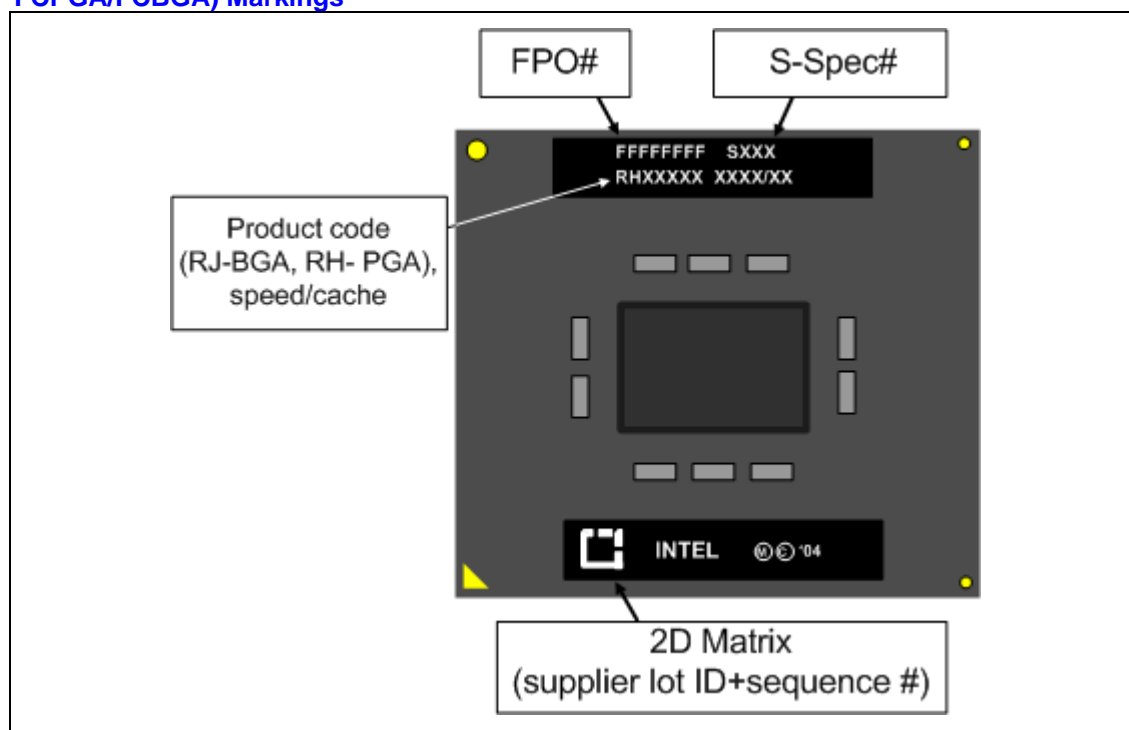
Figure 1. Intel® Pentium® M Processor on 90 nm Process with 2-MB L2 Cache (Micro-FCPGA/FCBGA) Markings
